# Memorandum

<b>To</b>	<b>From</b>	<b>Our reference</b>
Stephen Carpenter	Gareth Mason	IJD/GJM/261552
<b>Office</b>	<b>Date</b>	<b>Your Reference</b>
Bristol	16 December 2009	261552
<b>Subject</b>	<b>South Bristol Link - Geotechnical input</b>

Further to a request dated 23 September 2009, we have undertaken a brief desk study review of the proposed South Bristol Link route as shown on Drawings Nr. MMD-262581-C-DR-00-XX-1000 to 1003 (P3 revision).

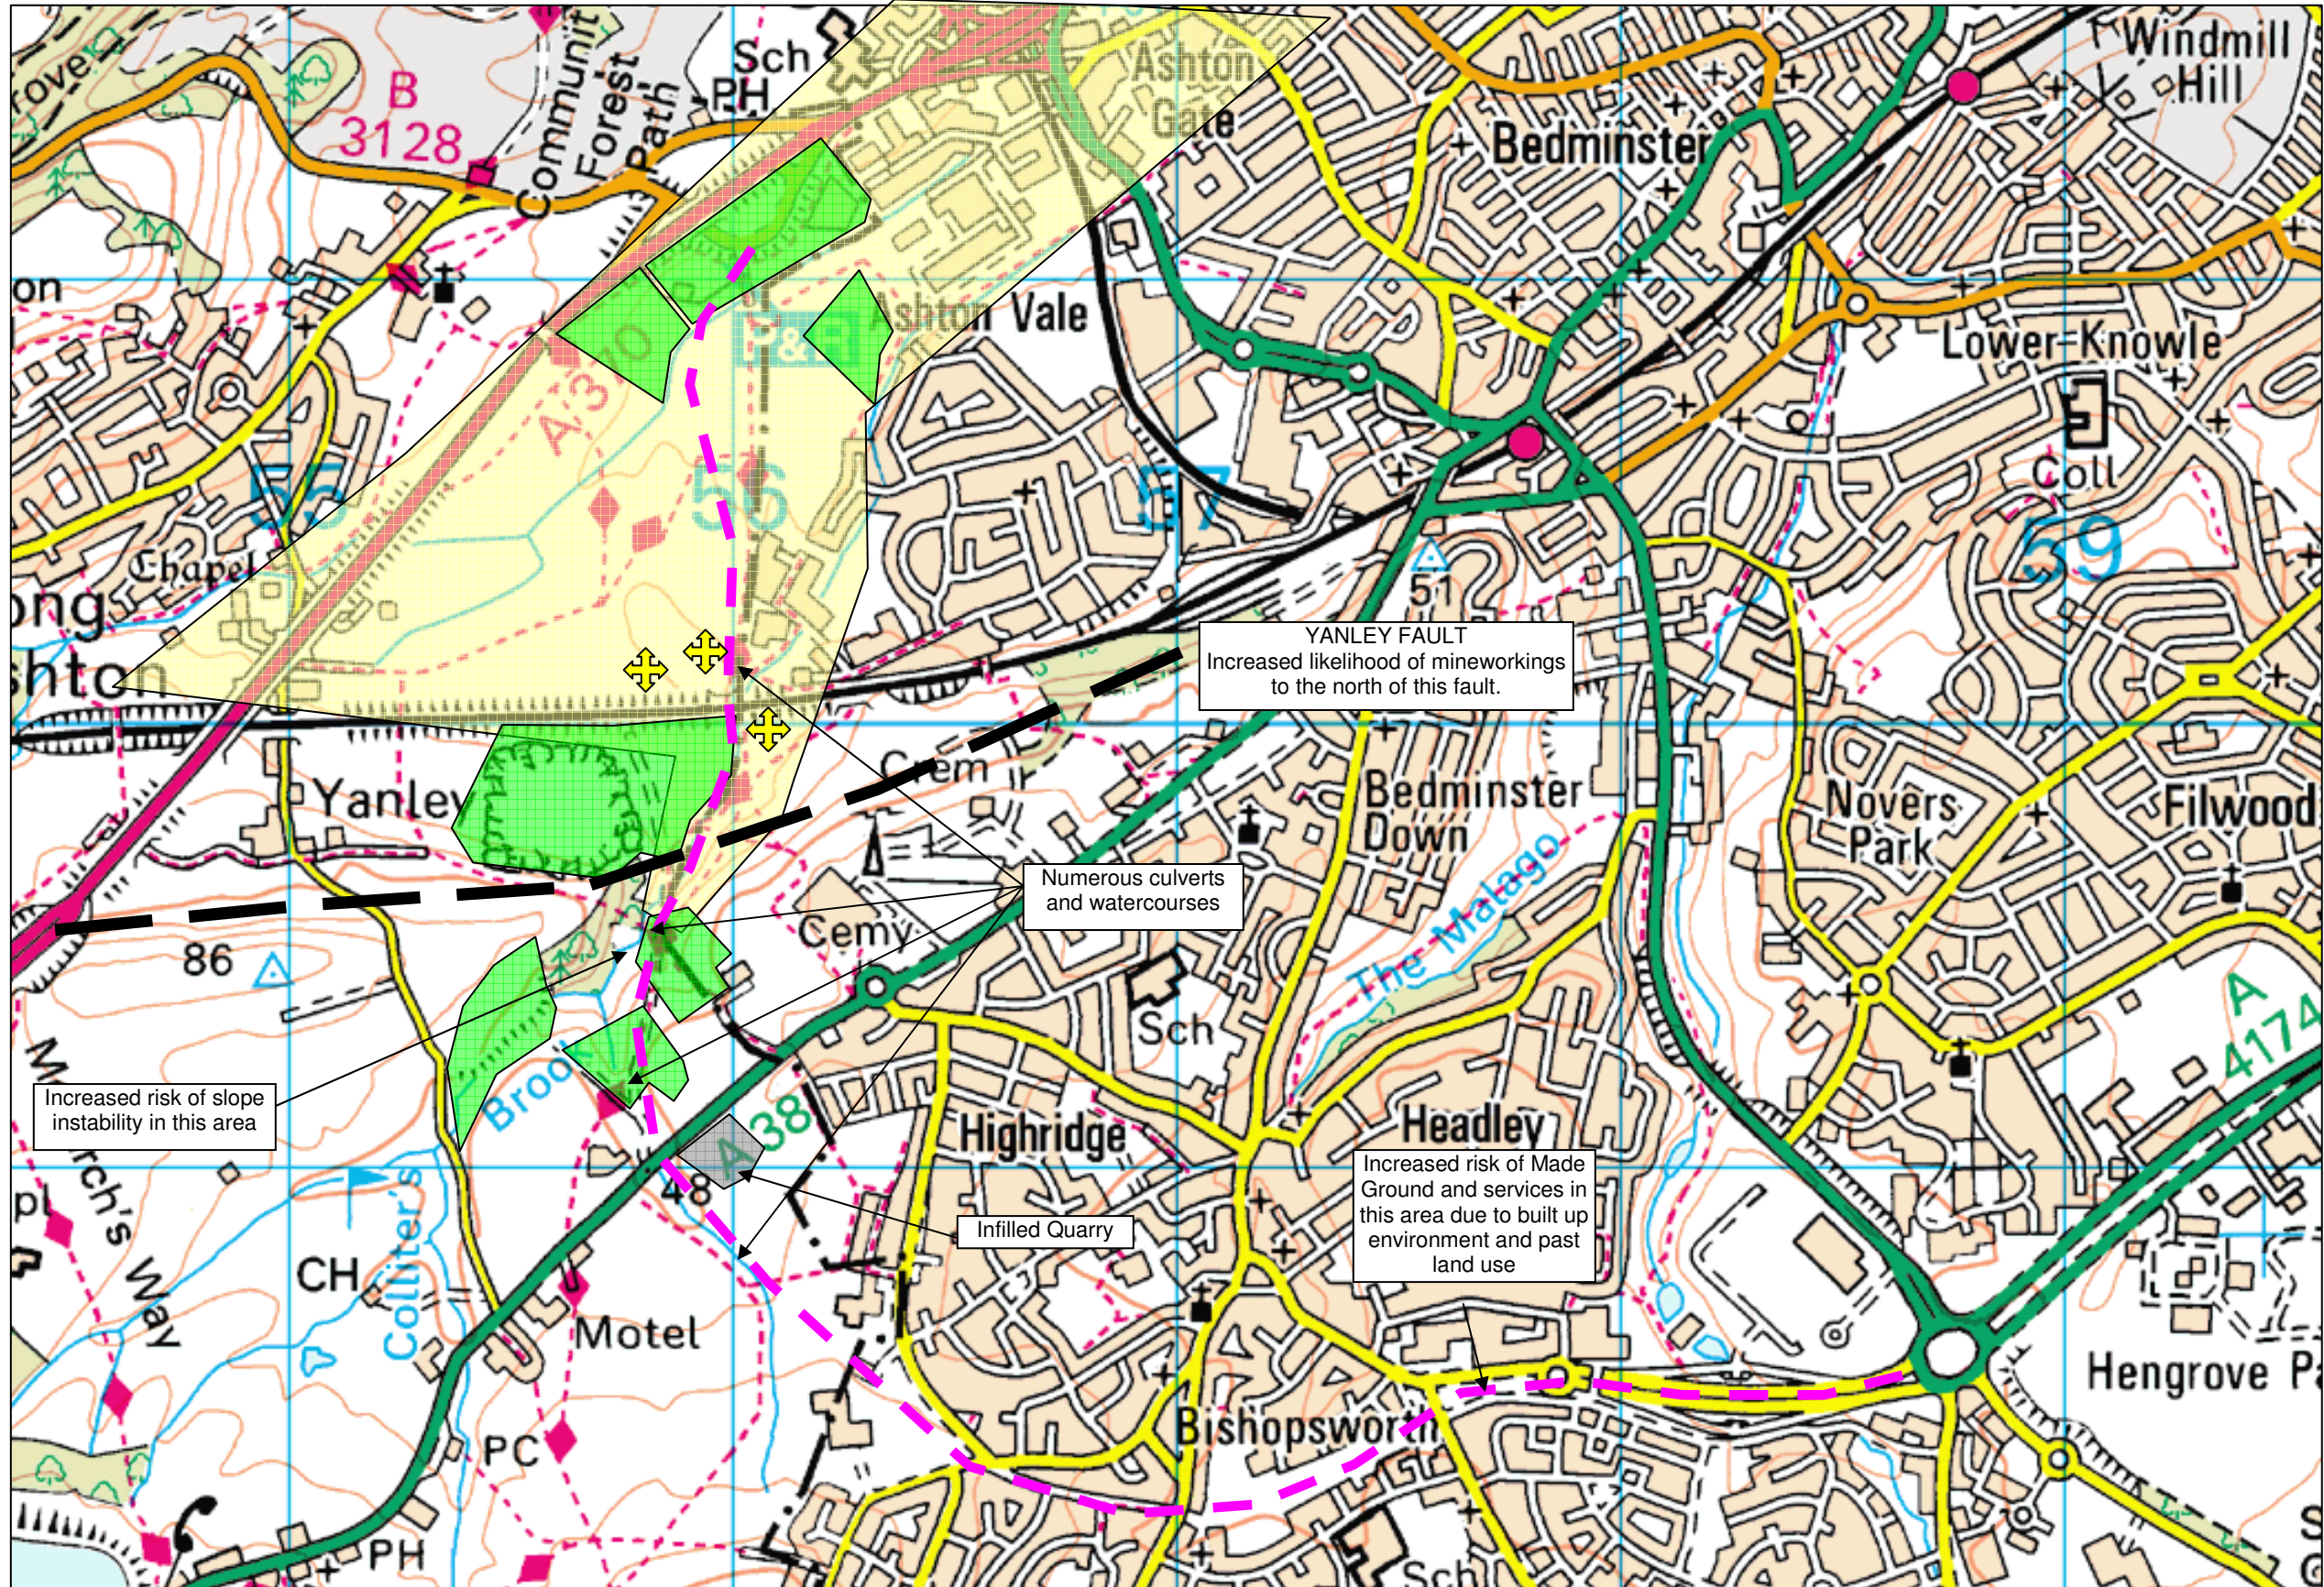
**KEY**

- Approximate location of Landfills
- Proposed Route
- Known mine entries
- Alluvium
